HITACHI EXCAVATOR AFTERMARKET, SERVICE EXCHANGE RELIEF & MAKE UP VALVES.

AVAILABLE!
HITACHI AFTERMARKET
RELIEF & MAKE UP VALVES

SERVICE EXCHANGE VALVES

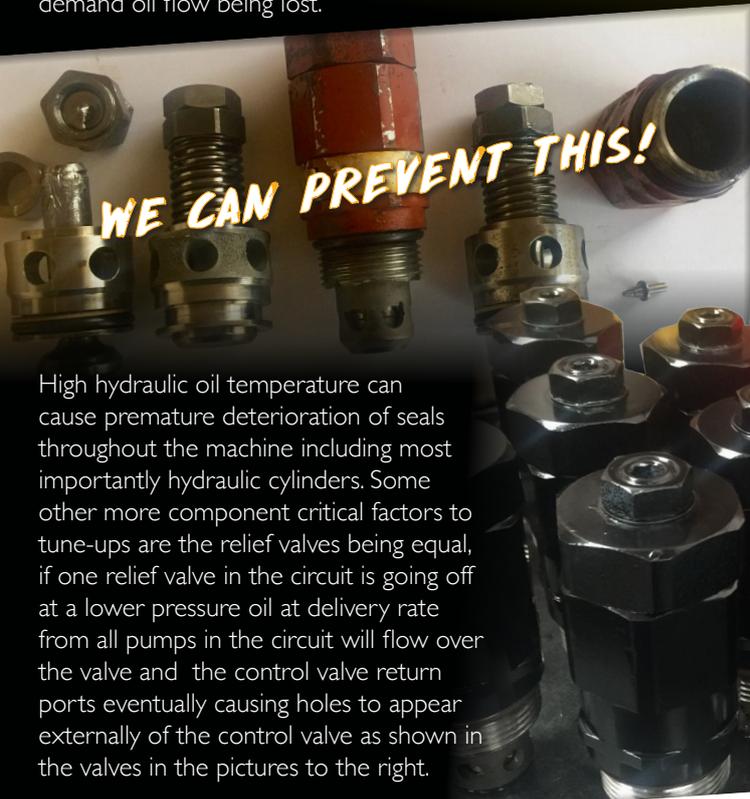
High hydraulic oil temperature can cause premature deterioration of seals throughout the machine including most importantly hydraulic cylinders. Some other more component critical factors to tune-ups are the relief valves being equal, if one relief valve in the circuit is going off at a lower pressure oil at delivery rate from all pumps in the circuit will flow over the valve and the control valve return ports eventually causing holes to appear externally of the control valve as shown in the valves in the pictures to the right.
